179
Defects in Plumbing
and Drainage Work

described by Francis Vacher
upwards of 100 illustrations

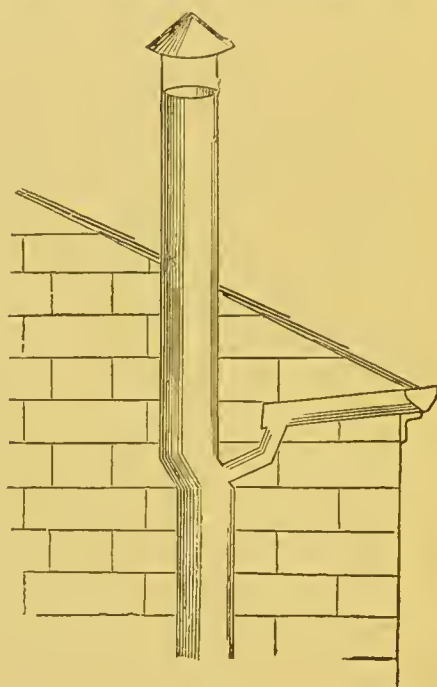
FIG. 66.

Fig. 66, from a correspondent, represents a soil-pipe ventilator into which the rain is conducted. The trapped bath waste and overflow, as well as the rain pipe, are connected with what is

intended as a ventilator to the soil pipe; but as this is sealed at its base by the contents of a syphon trap, the soil pipe is really unventilated. A pipe such as this, remarks my correspondent, is expected to convey rain and waste water downwards and a current of air upwards, and this occasionally at one and the same time, the effects of the compression of the contained air below the points of discharge, and of syphoning and trapping water, not being apparently considered. Ventilators as described

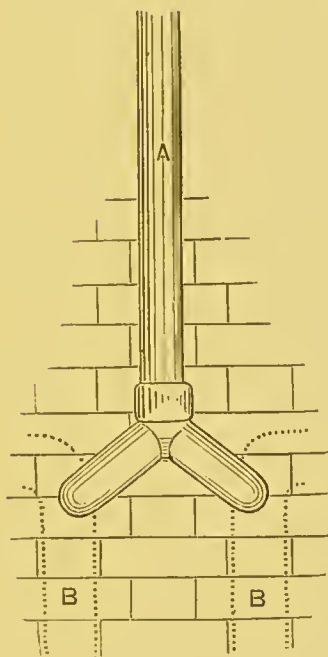
FIG. 67.

Fig. 67 represents two soil pipes built into the wall, and ventilated in a novel way. A pair of semi-detached villas had closets in the front, on the first floors over the lobbies. The soil pipes coming very near the surface of the wall on the inside were covered by about an inch of plaster; and in one villa the staining of this plaster and an effluvium nuisance gave indications of a leak. On calling at the villas with reference to this nuisance, the first thing noticed was the iron ventilator as shown which was connected with both soil pipes. It was not ill-fitted, and was carried up 9in. above the roof eaves. If a stoppage had occurred in either of the soil pipes, the contents would probably have overflowed into the common ventilator and choked it. A indicates the ventilator, B and B the two soil pipes.

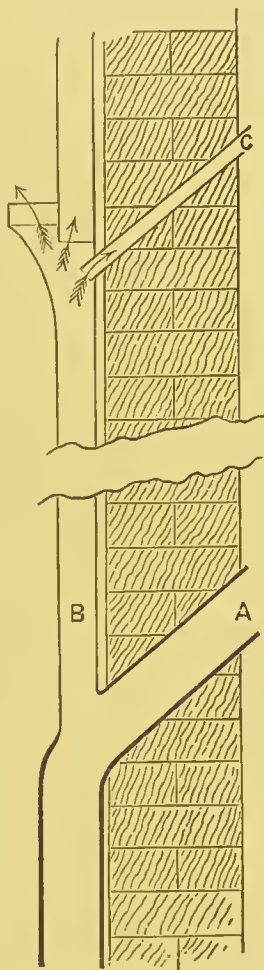
FIG. 68.

Fig. 68 represents an ingenious device for ventilating a soil pipe into a bedroom. Offensive smells in the bedroom were noticed and complained of. On inspection it was found that there was an open cistern in the bedroom, and that the overflow pipe from this was carried into the rain spout, which was made to act as a soil-pipe ventilator. A is a 4in. soil pipe taken out direct from a closet, B is a 2½in.

part of the foul air from the soil pipe was conveyed up the overflow pipe into the bedroom, part ascended the upper portion of the rain spout to the roof gutter, where a portion got in under the slates, and part was delivered externally to be drawn in at contiguous windows when open.

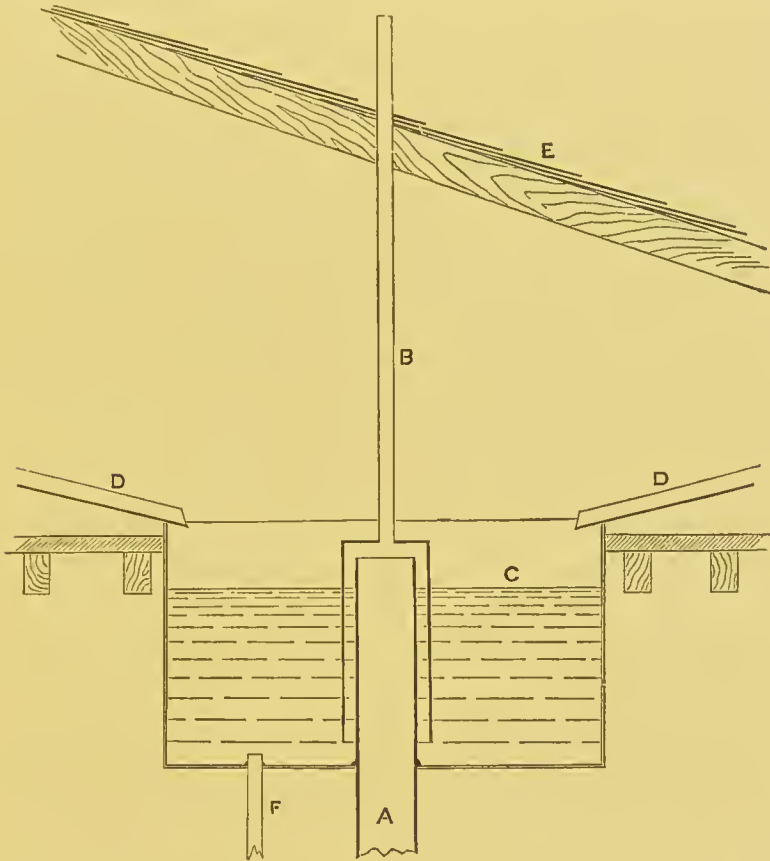
FIG. 70.

Fig. 70 represents part of a series of defects found in each of fifteen suburban residences, erected about twelve years ago. The soil pipe, of 4in. cast-iron pipes, was carried up through the bottom of the rain-water cistern to within two or three inches of the top, and made to act the part of overflow for the cistern. This is marked A in the cut. A zinc cap, in diameter two inches larger than the soil pipe, was placed in position over the end of this pipe, as a bell over a sink pipe. A zinc pipe B, an inch in diameter, was soldered round a hole at the top of the zinc cap, and the upper extremity continued above through the roof E, as shown. C is the rain-water cistern for flushing the closets, D and D the gutters from the roof, and F the flush pipe. As the soil pipe was directly connected with the main sewer, and the closet, soil pipe, and cistern were situated in the centre of the house, with no ventilation to the closet, sanitary arrangements could scarcely have been more defective. There were, however, houses in the same district in which the soil pipes were found continued upwards into the cisterns, and where not even one inch ventilators had been provided.

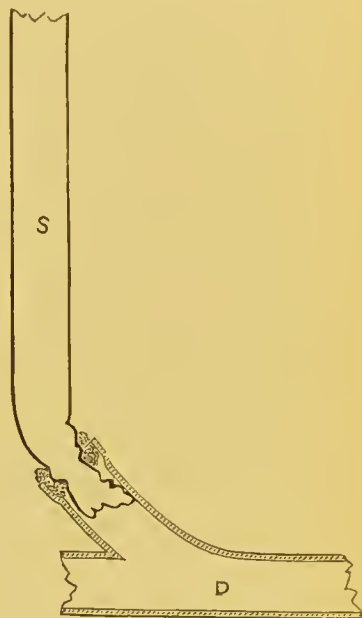
FIG. 72.

Fig. 72 shows a lead soil pipe S connected by a junction pipe D to the house drain. Instead of making a proper joint the workman had crumpled up the end of the soil pipe, and roughly thrust it into the pipe anyhow. It was cemented round, so that the joint did not actually leak, but at the joint the capacity of the soil pipe was reduced from being 4in. in diameter to being scarcely 2in., thus preparing the way for a stoppage sooner or later.

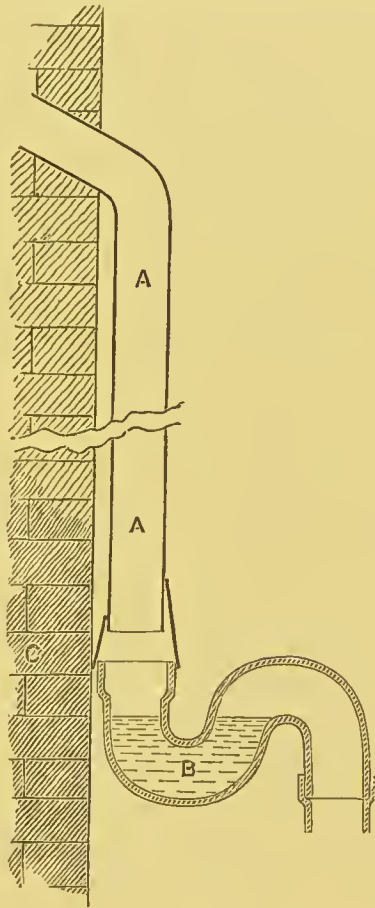
FIG 73.

Fig. 73 was sent by a correspondent in one of the largest towns in the kingdom. It represents an unventilated soil pipe, imperfectly connected with the trap at the foot. The connection consisted of four slates laid round the end of the soil pipe and trap. The result was that the contents of the soil pipe soaked into the ground and the contiguous portion of the wall, causing an effluvium nuisance inside the house. A indicates the soil pipe, B the trap, and C the saturated portion of the wall. Here

are three defects—the bad connection, the absence of a ventilator, and the trap at the foot of the soil pipe.

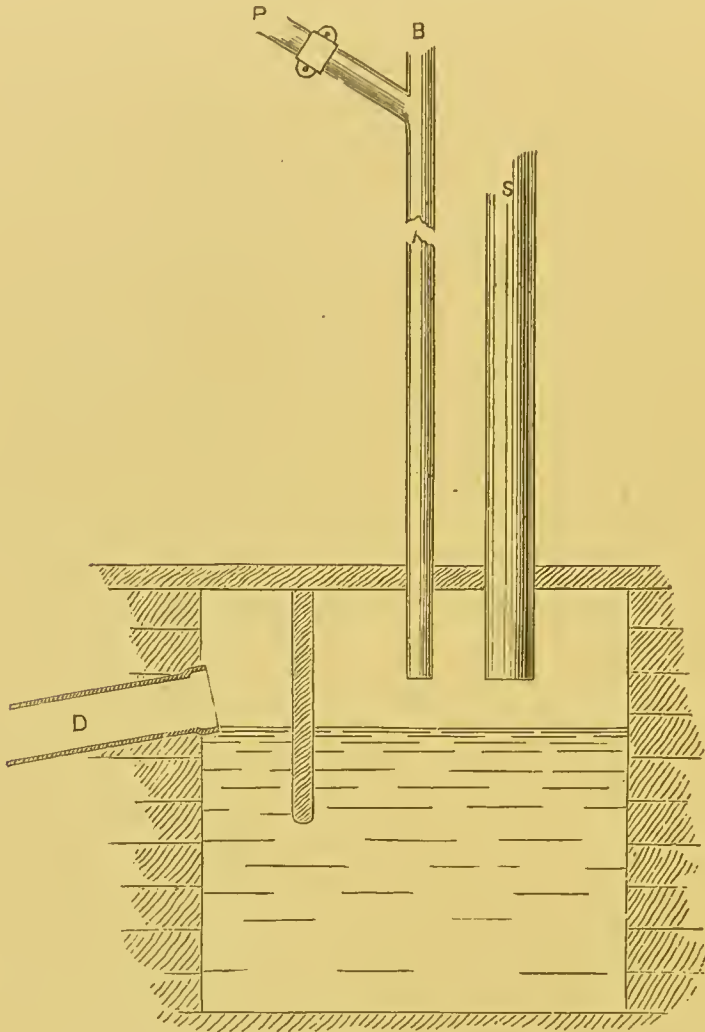
FIG. 74.

Fig. 74, received from a correspondent, is rightly described by him as a foul-gas generator. It represents a soil pipe S, and a waste pipe from pantry sink and bath, P and B, delivering into a covered pit measuring $2\frac{1}{2}$ ft. by $1\frac{1}{2}$ ft. and $2\frac{1}{2}$ ft. wide, and furnished with a mid-feather and outlet D, as shown. This arrangement was provided at a large house, and the workmanship was excellent though misapplied. The object of such a pit is merely to break the connection between the house and the public sewer, which can be done in a much more simple way, but what it actually becomes is a tank for intercepting the solids brought down by the soil pipe, and this is stirred up from time to time by the warm water discharged with considerable force from the pantry sink and bath.

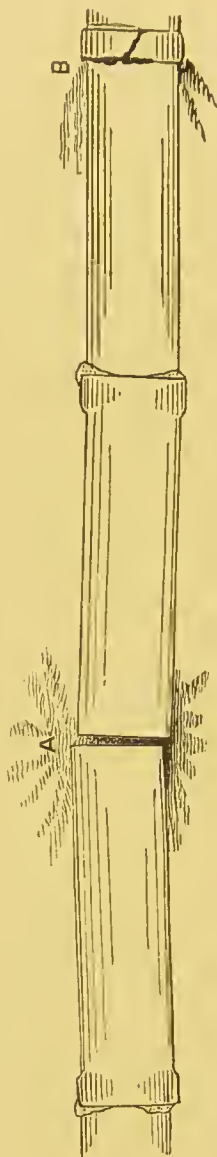
FIG. 78.

Fig. 78 shows another small portion. It will be noticed that two pipes are placed with the plain ends together, leaving an open joint at A, and the flange is broken off the pipe at B. Many of the flanges were found to be broken, and plain ends were placed together at two or three points.

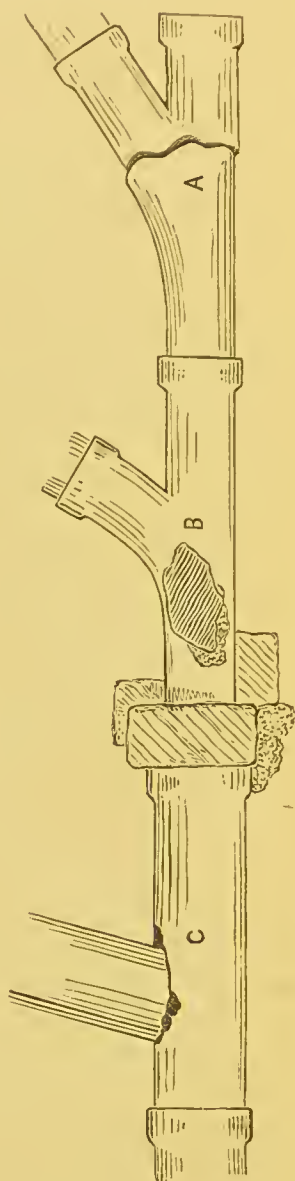
FIG. 79.

Fig. 79 represents the exact appearance of three pipes when the earth was removed from them. They are seen in plan, that is from above. At A is a 4in. junction, fractured right across, no proper bed having been made to support the pipe beneath.

the drain. Pipe B delivers into a 6in. pipe, there being a distance of fully 4in. between the pipes, the joint being roughly

made with brickbats and mortar. At C a hole had been knocked in this 6in. pipe, and another 6in. pipe from a gully trap roughly brought into it as shown. These three pipes are three consecutive pipes just as discovered. Of course the leakage from such a drain was enough to account for dampness in the neighbouring wall. However, the worst part of the drain is shown in section in

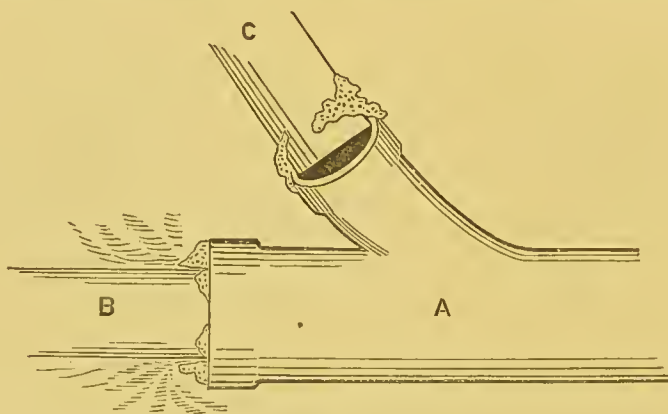
FIG. 82.

Fig. 82 represents a portion of a back passage drain, as seen from above. The drain should have been a 9in. drain with 6in. junctions. The drains of one of the houses delivering into it being obstructed, the passage drain was uncovered in rear of

this house, and defects as shown were discovered. The pipe A was so tilted up that the end of pipe C did not fit into the socket meant to receive it, and B, which should have been a 9in. pipe, was a 6in. one. The joints were in part made of clay,

and were defective. At the joint between A and B the drain contents had leaked out, and at the joint between A and C the earth above had got into the drain.

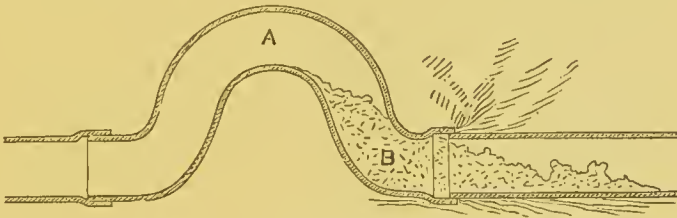
FIG. 84.

Fig. 84 illustrates an instance of remarkable stupidity that came under the observation of a correspondent from a small urban district. A 4in. earthenware pipe drain was not running, and it was exposed at the point where the stoppage appeared to be. The cause of the obstruction was at once brought to view. A trap had been introduced in the course of the drain, but it had been set *upside down*. None of the joints were properly made, and the pipe delivering into the trap had not been pressed into the flange that received it, and the drain contents had leaked out at this joint, saturating the surrounding earth. A is the trap set upside down, and B is the solid matter causing the obstruction.

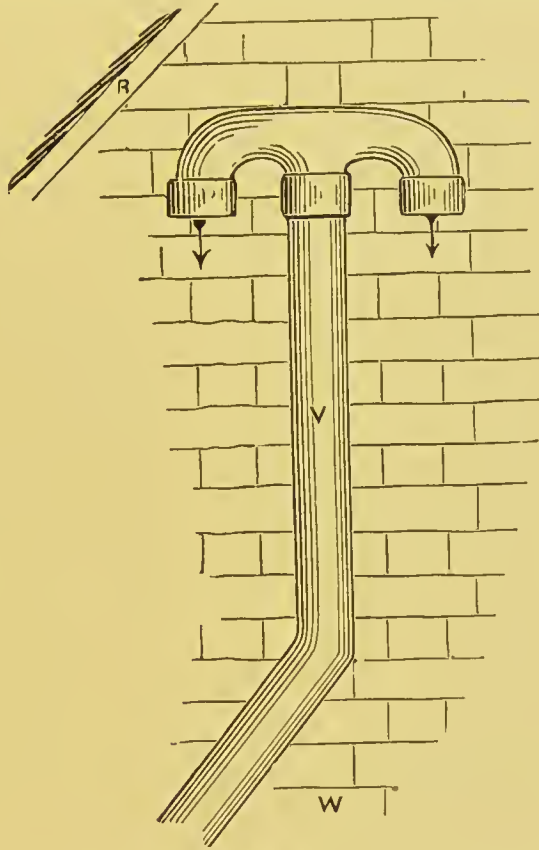
FIG. 87.

Fig. 87 shows the upper extremity of a drain ventilator. It was fixed to the gable wall of a large house, and instead of being carried up above the roof, in the usual way, it was turned obliquely to the right, apparently for no other purpose than to bring it over a window, and then it was capped with a terminal to direct any foul air it discharged downwards towards the window. V indicates the ventilator, which, with the terminal, was of 4in. cast-iron pipe. R shows a portion of the roof, and W indicates the position of the bricks just above the top of the window.

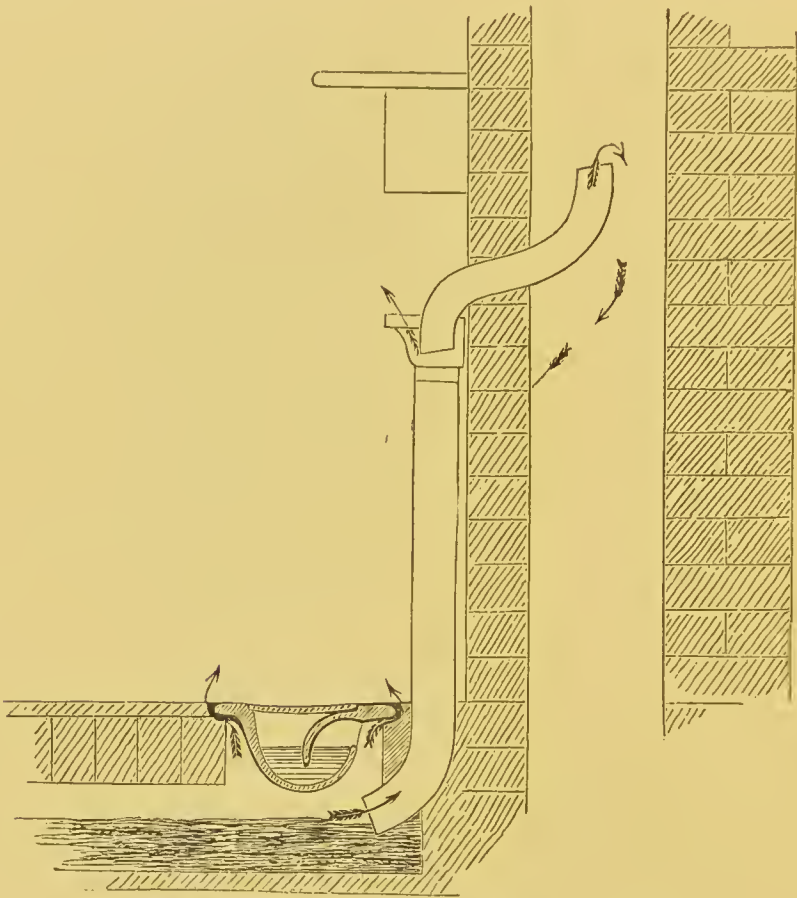
FIG. 88.

Fig. 88 represents a resident owner's attempt to remedy a defect in his house. In the basement of the premises was a rubble drain, laid without fall, the entrance to which was guarded by a loose D trap. Such a drain (it was continued from this house under three or four others) was necessarily a drain of deposit, and the effluvia arising therefrom had free access to the house, the traps notwithstanding. The owner thought he could remedy the nuisance by fixing a perpendicular pipe as shown, through which he could flush the drain and keep it clean.

The pipe was accordingly fixed, and buckets of water poured down, but the nuisance remained. Having an idea (not an uncommon one) that the current of air is always upwards in a chimney, the

owner next carried a pipe, from the head of the flushing pipe, for about a foot up the chimney. The result of the owner's remedial measures was that the effluvia, instead of coming up merely at the edges of the loose trap, had free exit at the flushing

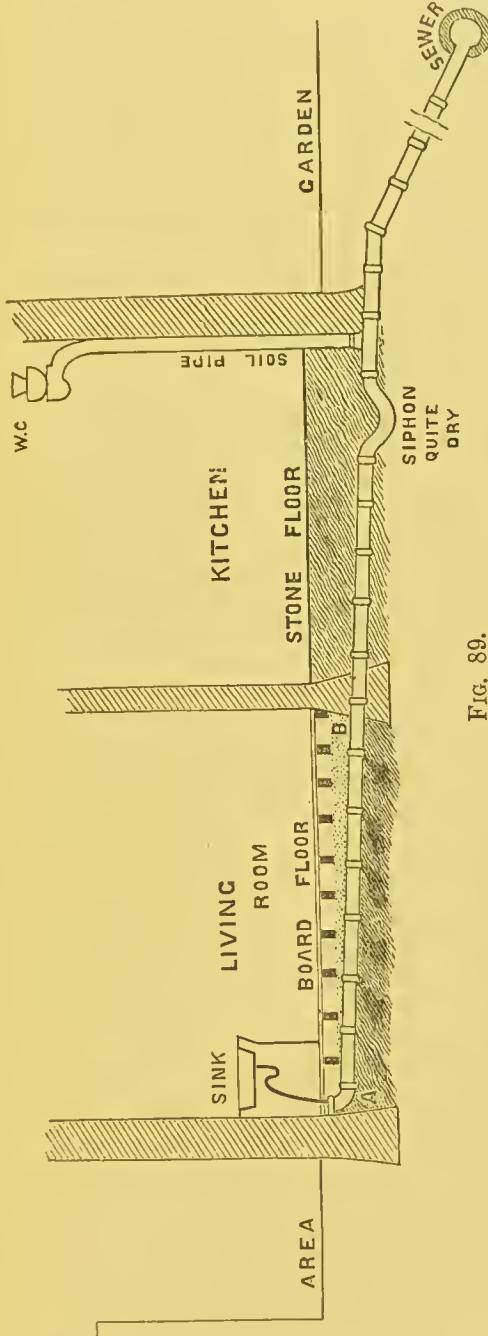
FIG. 89.

Fig. 89 shows the sanitary arrangements of a large boarding-house at an inland watering-place. The correspondent who supplied the sketch was recently called on to make an investigation, and the section of the basement of the building represented in the cut correctly indicates what he discovered. My correspondent writes: "There was no intercepting trap between the public sewer and house connections, but a syphon trap had recently been inserted in the drain passing under the house, and new pipes had been laid under the living room. This had been done to get rid of a bad smell which had been noticed in the living room. On pulling up the floor of the living room I found the pipes laid on the ground, the joints being quite open, the pipes loose, and partially covered with sawdust. The sawdust and soil were saturated with foul water from the sink in the pantry adjoining the living room, the water from this sink having all escaped through the open joints. Although the trap under the kitchen floor had been inserted nearly a year, no water had ever reached it. The sewer gas had therefore free access to the house by the living room." A is the saturated soil and B the saturated sawdust. All the joints from A to B were open.

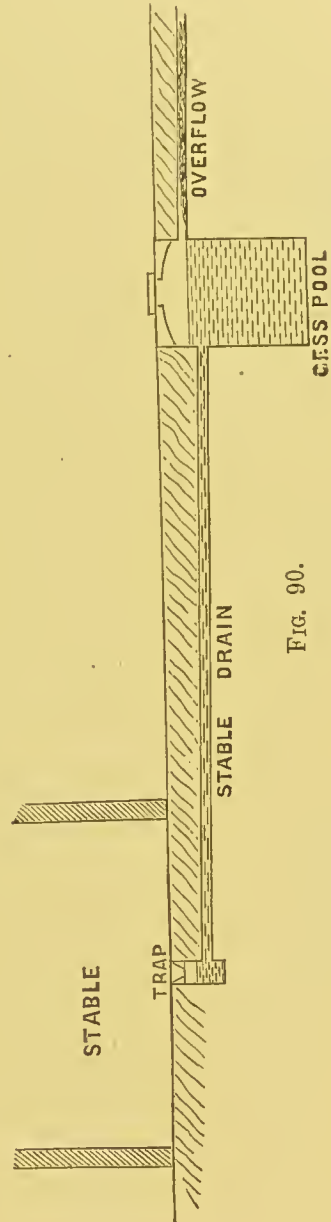
FIG. 90.

Fig. 90, which was received with the above, is a section showing the arrangements found at large stables, where, an epizootic among the horses had led to an investigation. The drain was of brick, 6in. by 6in., laid without mortar or cement; the cesspool was 7ft. by 4ft., and 5ft. deep; and the overflow was made of agricultural drainage pipes. "On opening up," writes my correspondent, "I found the stable drain charged and the overflow blocked. The overflow had been placed at too high a level, and the drain itself was flat. On the same premises the overflow from the cistern from which water was obtained for the horses had direct communication with a cesspool."

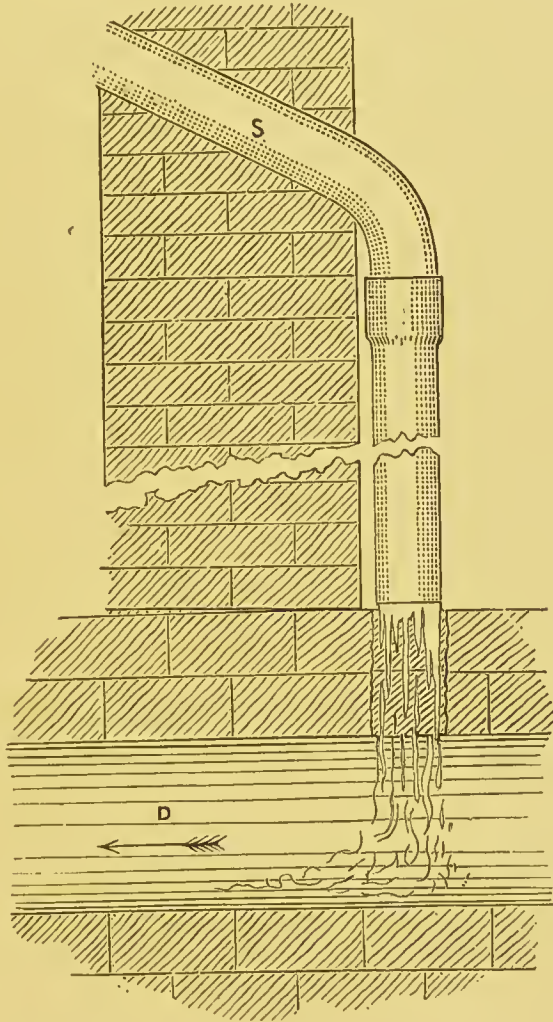
FIG. 91.

On examining a large old house in the suburbs (where there had been complaints of effluvia and sickness, which the practitioner in attendance thought pointed to insanitary conditions), a defective brick sewer was found under the premises, and the cause of nuisance indicated. The house was conveniently situated for draining into the town sewer, but the old sewer originally provided, running under the garden and delivering into the river, had not been interfered with. The tenant had been induced to think that the drains were properly arranged, and external to the house, *as the soil pipe was carried down outside*. I pointed out that it was not ventilated, and on removing the earth at the foot brought to light the old sewer

running under the house. The length of iron soil pipe ($4\frac{1}{2}$ in. pipe) had not been quite long enough to reach to the sewer, so a hole had been roughly cut in the sewer and the soil pipe delivered over it, no joint having been attempted. In Fig. 91, S is the lead soil pipe properly jointed to an iron soil pipe. The way this delivered into the drain D is shown.

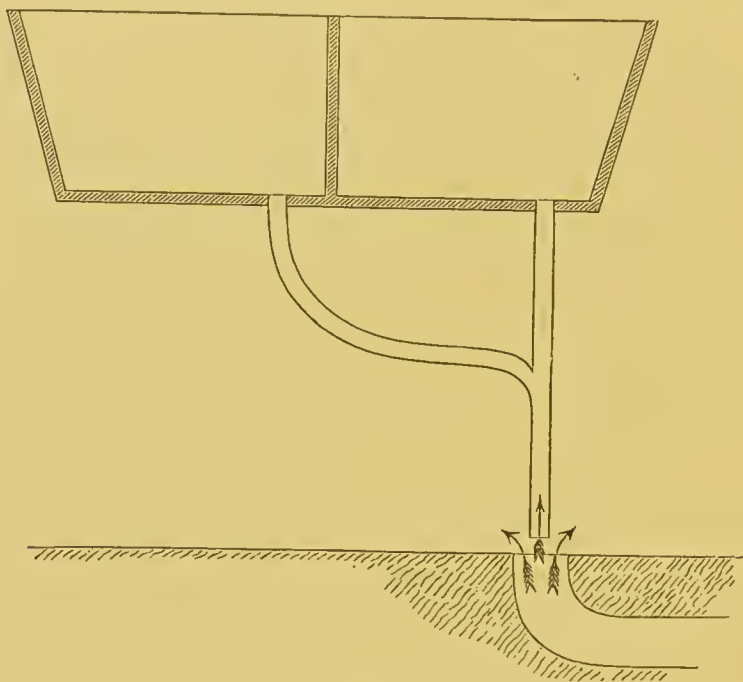
FIG. 92.

Fig. 92 represents an untrapped drain in a washhouse adjoining a kitchen. Complaint was received from the occupant

of the premises of an effluvium nuisance. Two fixed washtubs discharged over a grating in the floor, and on the grating being removed it was found that the washhouse drain was without a trap of any kind, and delivered into the sewer direct. The arrangement is shown in the illustration. The owner of the house was a builder, and yet when communicated with and directed to abate the nuisance he at first insisted on connecting

the waste pipes from the washtubs with the washhouse drain. It was pointed out to him that this could not check the ingress of sewer gas, but would merely deliver it at a higher level, and that whether the waste pipes from the tubs were connected with the washhouse drain or not, the latter would have to be severed from the sewer by a gully trap, or in some other efficient manner.

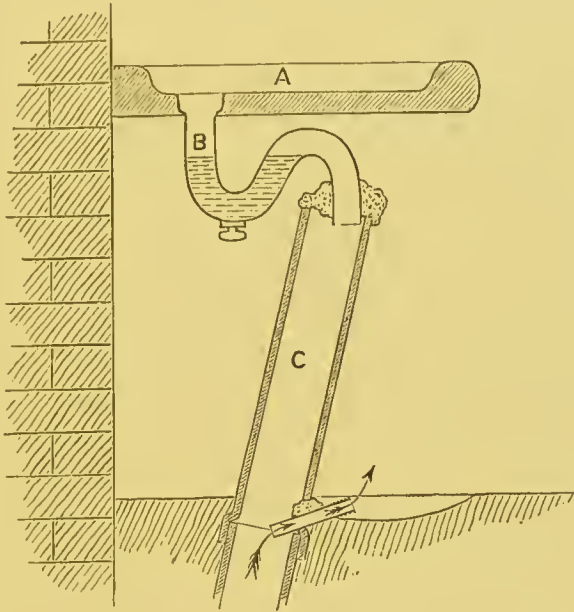
FIG. 93.

Fig. 93 shows in section a sink as fitted in the basement of a small house let at about 8s. a week. The sink waste pipe was trapped with a large iron (*f*) trap, and delivered into a 4in. glazed earthenware pipe, and thus to the drain. The basement being used as a washhouse, some sort of drain was required for the floor, and this was provided in the following way: A small dish-shaped depression was made near the sink, and a short

length of iron pipe carried from this to the glazed earthenware pipe. This iron pipe was fitted with a brass cap, which screwed on. After the washing was over for the day, the cap was screwed off and the tubs emptied, and then the cap screwed on again. Of course, in practice, the cap was not always screwed on at once; and one night that it chanced to be left off, the effluvium nuisance was so bad as to cause the woman of the house to get up and search for the cap and put it on. A is the sink, B the iron trap, and C the glazed earthenware pipe. The whole arrangement was unworkmanlike, but B was jointed to C quite securely with cement, and the floor near the sink was finished off with cement, so that the only direct communication between

the inside of the house and the drain was through the short iron pipe described.

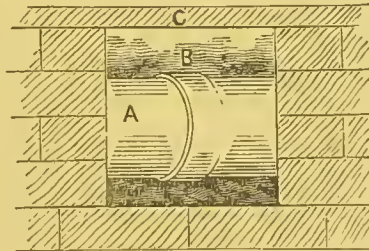
FIG. 94.

Fig. 94 represents a curious case of obstruction which I discovered in making an examination of a very large house. It was ascertained that the obstruction was in an old drain under

the area. On removing the flags a square brick-lined drain was brought to view, and crossing this obliquely was a 6in. pipe drain, which was the immediate cause of the obstruction. The pipe drain had been laid in connection with additional sanitary accommodation recently provided, and those responsible for the work seem to have been indifferent as to the effect it must have

on the old drain. A is the pipe drain, B the old brick drain shown in section, and C the area flagging.

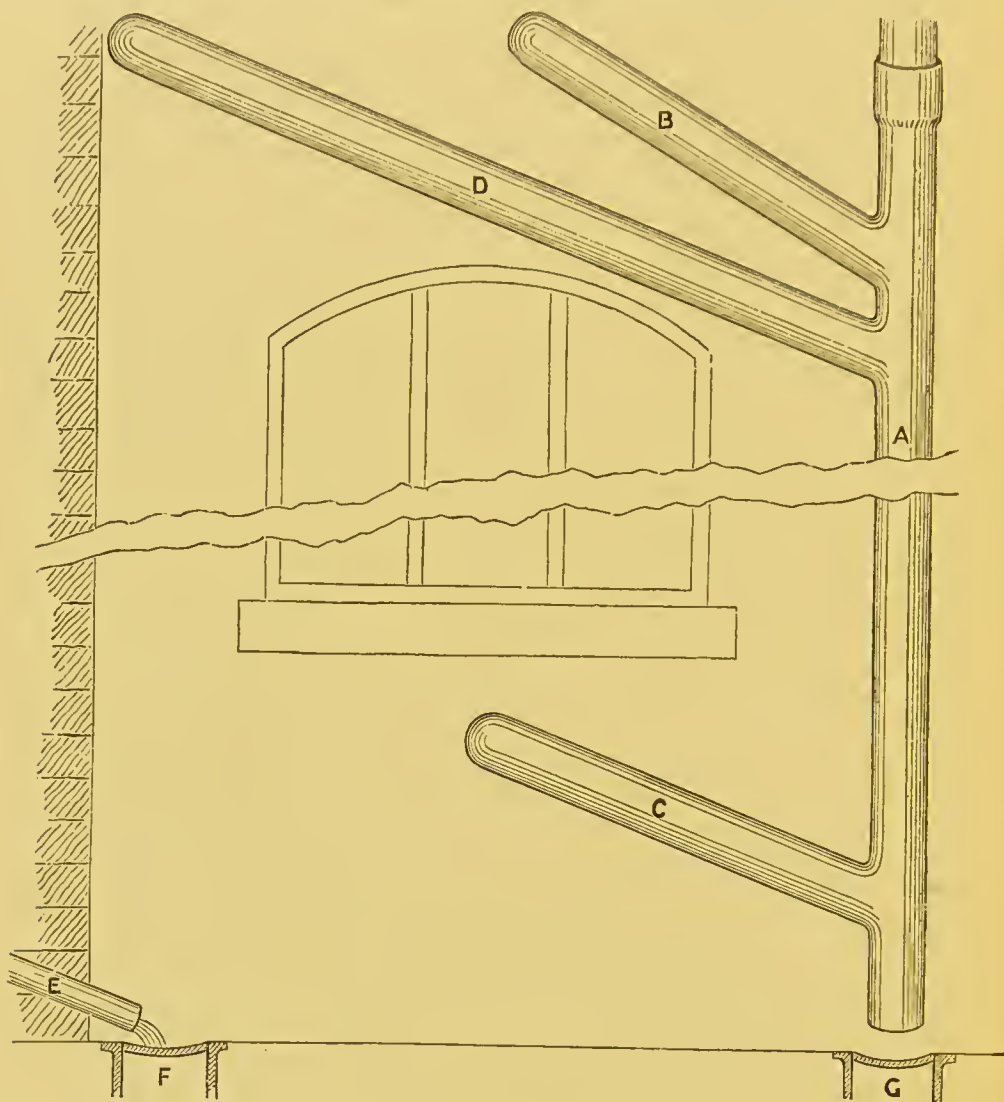
FIG. 95.

Fig. 95 is a specimen of ill-planned work in connection with a hospital. One of the peculiar features of the hospital is that there are two distinct drainage systems—one for so-called "sewage," which is specially treated, and one for surface water,

which passes into a pond. It was arranged that all bath and lavatory waste water was to pass into the foul water, or "sewage" system. As the work was carried out, it seems to have been left to chance as to which system of drains the waste pipes delivered into. A is a rain spout from the roof, delivering on a gully trap G, connected with the surface water drain; B and C are dis-

charge pipes from the first floor and ground floor lavatories; D is the discharge pipe from the first floor bath—all these being connected with the rain spout A. E is the discharge pipe from the ground floor bath, delivering on a gully trap F, connected with the foul water drain. The 4in. earthenware pipe drain leading from F crossed over the 4in. earthenware pipe drain from G, the one lying almost close to the other. A, B, C, and

D are 4 in. iron pipes. E is a small lead pipe, as shown. "The object of this blundering," writes the correspondent who furnishes me with these particulars, "is difficult to see, as it would have been far simpler to discharge all the bath and lavatory water on a grid in F." The most economical way of remedying the mistake appeared to be to connect the gully G with the foul-water system, and this has now been done.

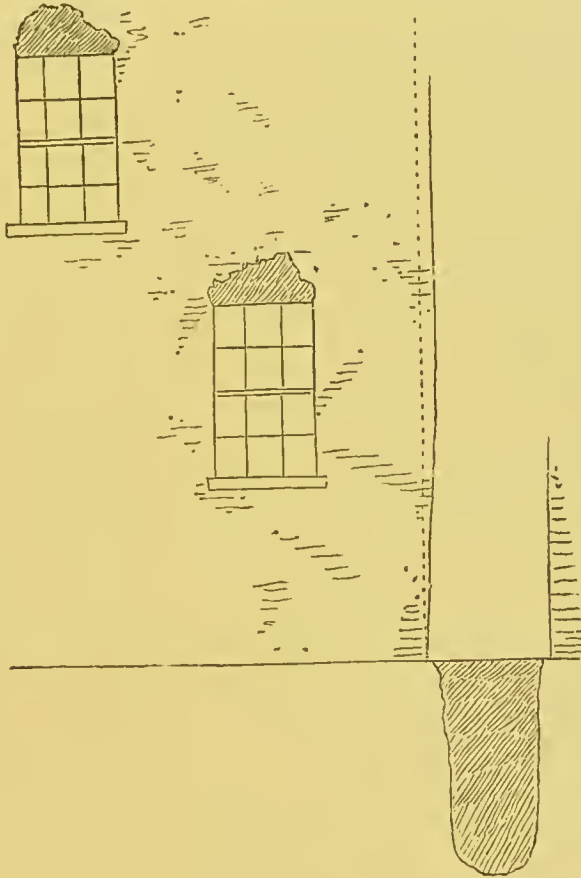
FIG. 96.

Fig. 96 shows the effects of not shoring up a wall before digging a trench close to the wall footings. Earth was removed

from a back passage, to the depth of about 9ft., in order to reconstruct a drain, and as a result the wall parallel to the trench got out of the perpendicular, as shown in the dotted lines in the sketch. Some time after the ground had been filled in, the brick arches over the windows fell out as indicated. Workmen often appear to think that shoring up the sides of the trench in such a case is sufficient. The house on the opposite side of the passage was much larger and higher, and thus not so liable to be affected.

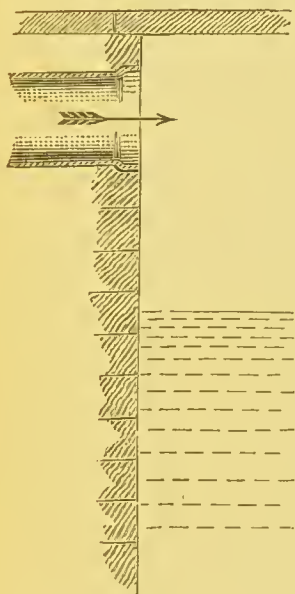
FIG. 97.

Fig. 97 represents a portion of the interior of a terra cistern, the overflow pipe from which is carried directly into the drain. Connecting the cistern overflow to a drain is, I regret to say, a

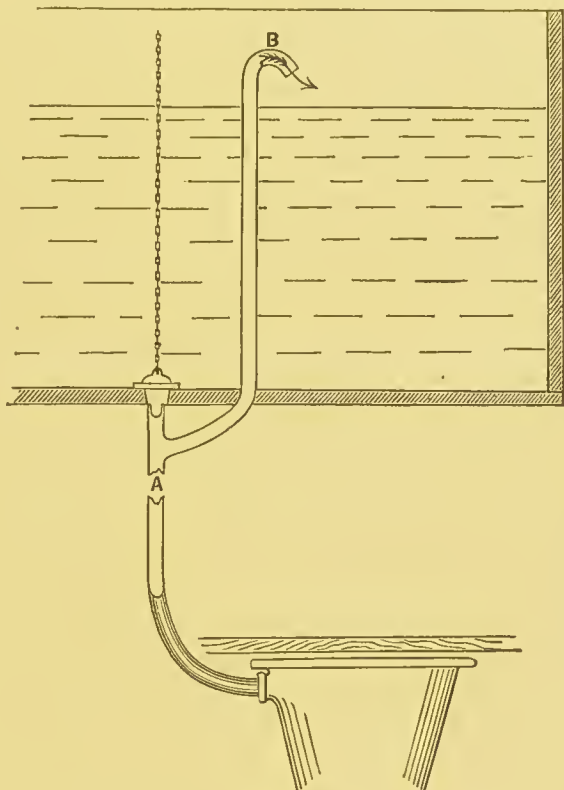
FIG. 98.

Fig. 98 represents a portion of the interior of a domestic store cistern, used for flushing a closet, and for other purposes. A is the flushing pipe brought down to the closet basin, and B is a so-called air pipe, which discharges foul air out of the flushing pipe on the surface of the water in the cistern. Of course it would be just as simple an arrangement for the air pipe to deliver externally, and if the flushing pipe is big enough no air pipe is required.

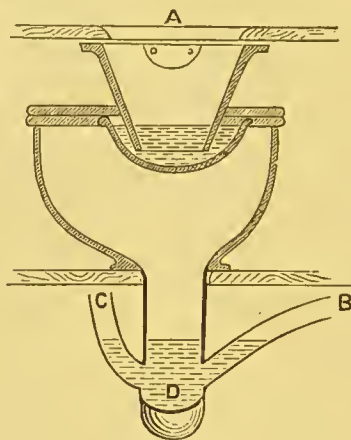
FIG. 99.

In a house in which there had been much sickness, and where there was reason to believe the water had become polluted, was found an old pan closet of the ordinary form—*vide* Fig. 99, A.

Into the trap D below were carried two pipes, the bath waste B entering on the one side and *the overflow from the cistern* C, at the top of the house, entering on the other side. The trap was continued as a soil pipe (inside the house and unventilated), delivering into an ill-jointed drain under the basement.

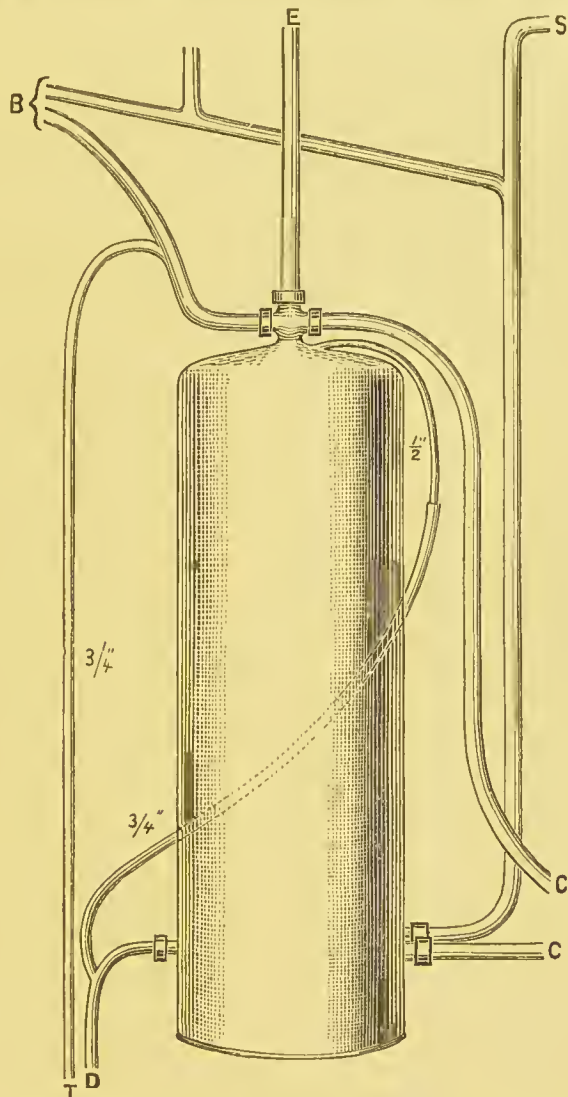
Fig. 100 illustrates an instance of defective plumbing which was made manifest owing to frost. I was informed that a copper cylinder, which had been fixed ten years since, and had hitherto given no trouble, had suddenly collapsed, the copper being rent in two places. On arriving at the premises I found the cylinder a hopeless wreck, and water still spurting from one of the rents. The cylinder measured 4ft. by 1½ft., and was fitted as shown. C and C are the circulating pipes, E the expansion pipe, S the cold supply, T a hot water tap for the kitchen, D the draw-off pipe for emptying the cylinder, which

was also used to supply a bath on the kitchen floor, and B a hot and cold pipe leading to a bath on an upper floor. I traced the supply pipe, and found that from the point S it was horizontal for 39ft., out of which 30ft. ran along an external wall, then it ascended along an external wall to a cistern, at the top of the house. It was not surprising that this pipe had frozen. The next thing was to trace the expansion pipe, which was led up

and made to pierce the roof, where the end had become choked with snow and ice. The bath had been in use once or twice since the frost, and as the cylinder cooled, the collapse had taken place. All the pipes were $1\frac{1}{4}$ in. except those marked. It is not easy to understand the intention of the $\frac{3}{4}$ in. extending from the pipe D, and continued as a $\frac{1}{2}$ in. to the top of the cylinder. It appears to have been put in as an afterthought. Probably the water in the bath supplied from D was not found to be hot enough, as

it came from the cold end of the cylinder, and matters were improved in the "jerry" way indicated. It will be noticed that the return pipe from the boiler is entered at the top of the cylinder—the approved practice is to enter this as well as the flow at the bottom of the cylinder. It is interesting to note that although this cylinder collapsed it had been fitted with a

so-called "vacuum valve." The function of this little apparatus appears to be to give a false sense of security. How often it happens that when its services are really needed it is stiff and does not act!

The fixing of 39ft. of lead pipe horizontally, as just referred to, is work which would only be done by a careless or ignorant

plumber. A pipe should always be given a sufficient fall to enable it to be emptied if required, and when nearly horizontal should be laid on a piece of wood.

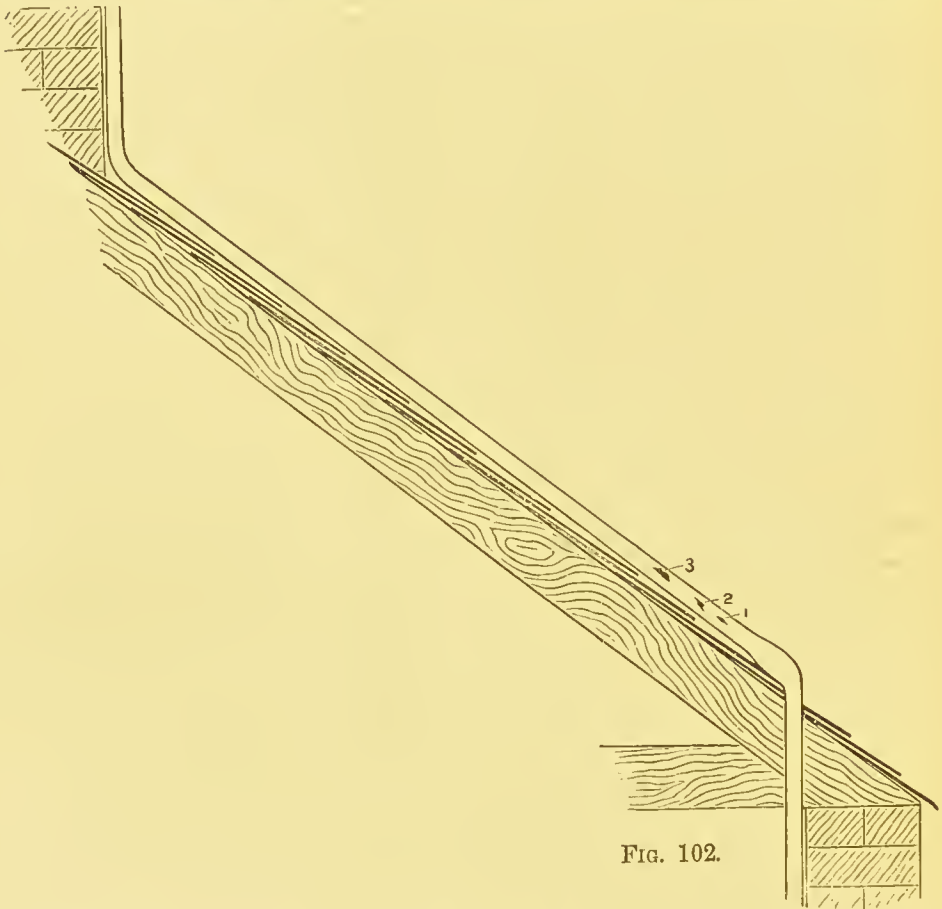
FIG. 102.

The next illustration, Fig. 102, shows the expansion pipe from a hot water cylinder, which was ruptured by frost three times between Christmas and the middle of January. Every plumber knows that an expansion pipe should not be exposed to the action of frost, yet the pipe shown was carried along the roof, unprotected for five feet, and then up a chimney for four feet. Just beyond the point where it pierced the roof there was a joint, and the first rupture occurred close to this at 1. After it was mended, a second rupture occurred at 2; and after this was mended, the pipe burst for the third time at 3. The

chimney was from a kitchen, and was practically always warm, and if the pipe, instead of being carried along the slates, had been made to pierce the roof where the chimney came through, it would have been efficiently protected from the action of frost.
